RENTON POLICE DEPARTMENT

Information Bulletin

ATM FRAUD

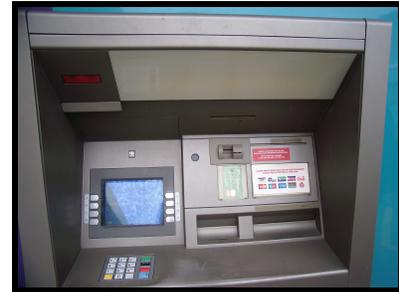
ATM with Added-on Card Slot and Camera

- Entirely conceal the keypad from view when you punch in your PIN.
- Monitor your account regularly for fraudulent activity.
- Use the same ATM for most of your transactions, and be alert to any change in appearance of the machine. If the ATM looks different, call the 800-number on the machine and report it.
- Immediately report any suspicious activity or people in the area to 9-1-1.

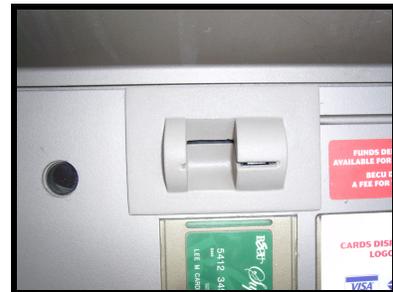
Per the financial institution, when a customer puts their ATM card into the added-on the slot (which fits over the "real" card slot), the card is "read" by the added-on device. Then the added-on camera, which is aimed towards the keypad, records the view of the keypad as the customer punches in their PIN.

Added-on Card Slot

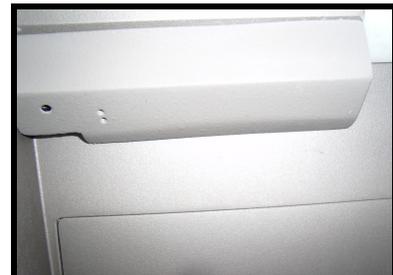
Added-on Camera
